FIRE INVESTIGATION REPORT

**World Trade Center Explosion and Fire
New York, New York
February 26, 1993**

**Michael S. Isner
Fire Protection Engineer
National Fire Protection Association**

**Thomas J. Klem
Director of Fire Investigations
National Fire Protection Association**

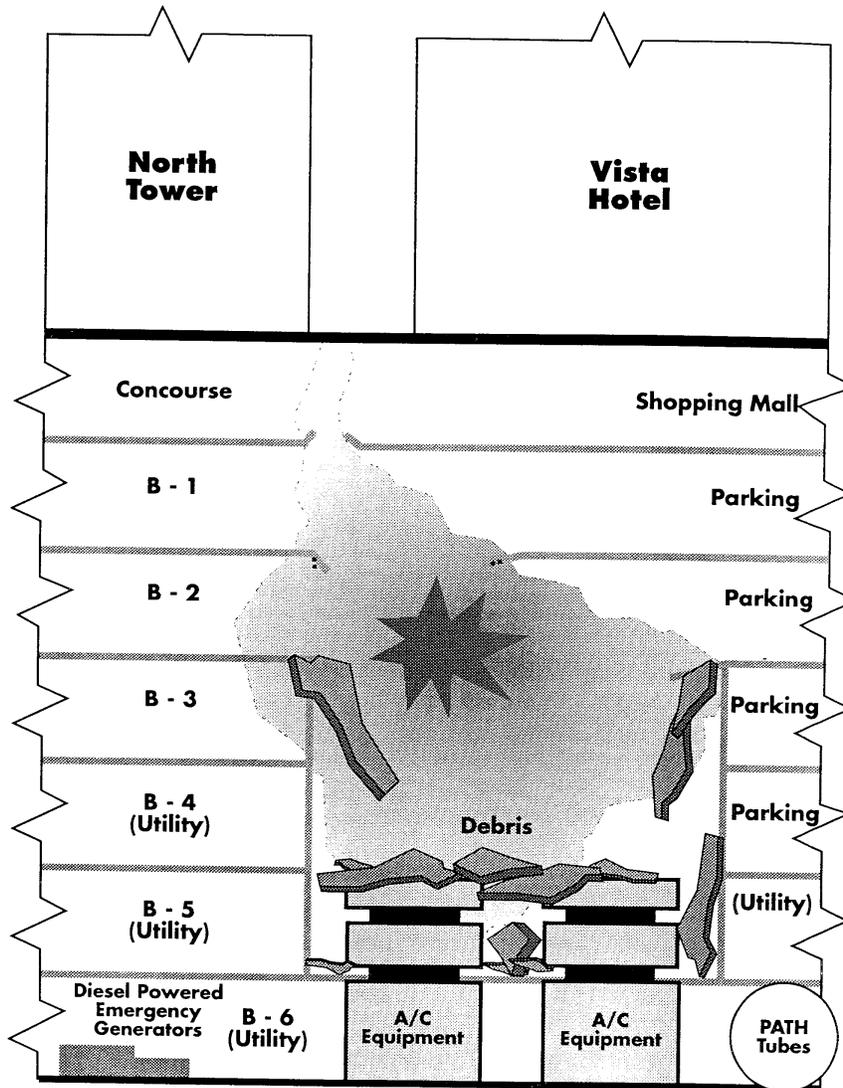
CONCOURSE & BASEMENT LEVELS
Figure 8

The explosion resulted in a large crater involving six levels of the complex. (See Figure 8.) The top-most point of the crater was a 10-ft by 10-ft section of the Plaza floor slab which was cracked and deflected upward. On the next level down, the Concourse level, a plaster-on-metal-lath ceiling collapsed in the Vista Hotel function room, and directly below the collapse, there was an approximately 18-ft by 22-ft hole in the floor slab caused by the explosion below. On the B1 level there was an approximately 50-ft by 80-ft hole where the floor slab had also collapsed. The largest floor slab collapse occurred on the B2 level. On this level, the collapse area was approximately 130 ft by 130 ft. (See Figure 9.) There were no floor slabs at the B3 and B4 levels directly below the explosion area. As a result, debris from the explosion area and the collapsing floor slabs dropped down to the B5 level, where this material landed on the large refrigeration equipment.

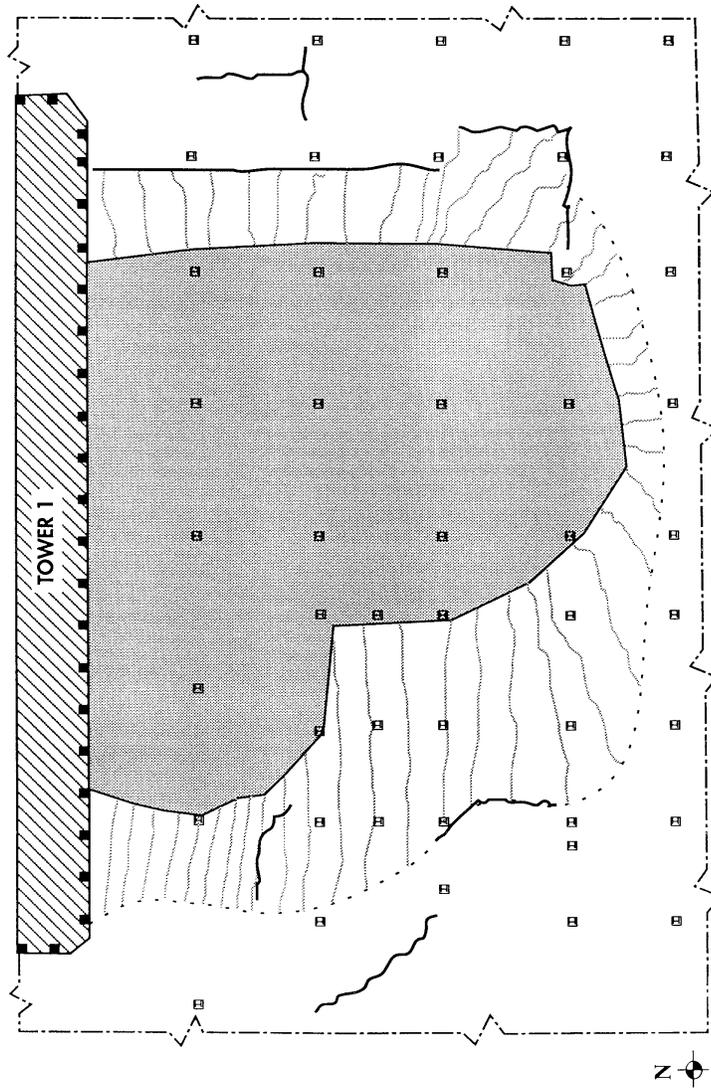
DAMAGE TO B-2 FLOOR SLAB
Figure 9

Crack in Slab

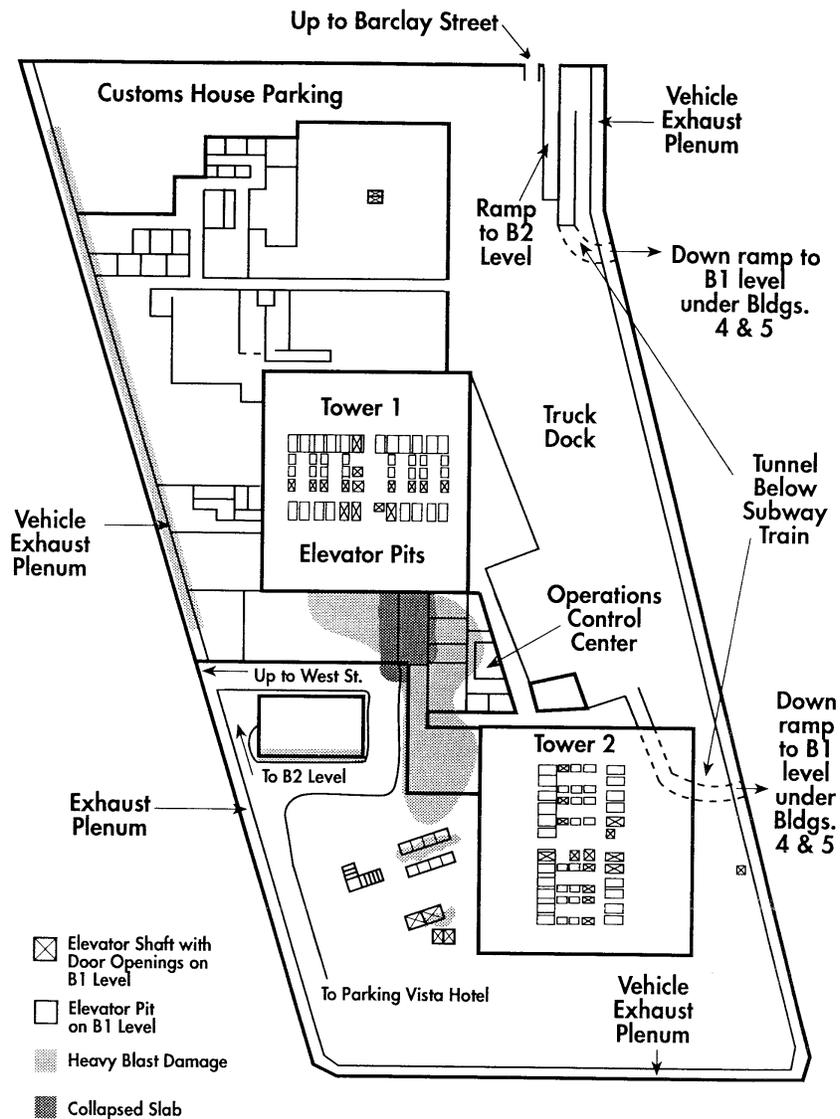
EXPLOSION DAMAGE, B1 LEVEL
Figure 10

The explosion damage also extended to areas well beyond the immediate crater. Concrete block walls on the B1 level were damaged to the point that they needed to be replaced. The damaged walls included numerous nonbearing walls enclosing rooms adjacent to the area of the explosion, and some of the walls formed a vehicle exhaust plenum along the perimeter of that level. (See Figure 10.)

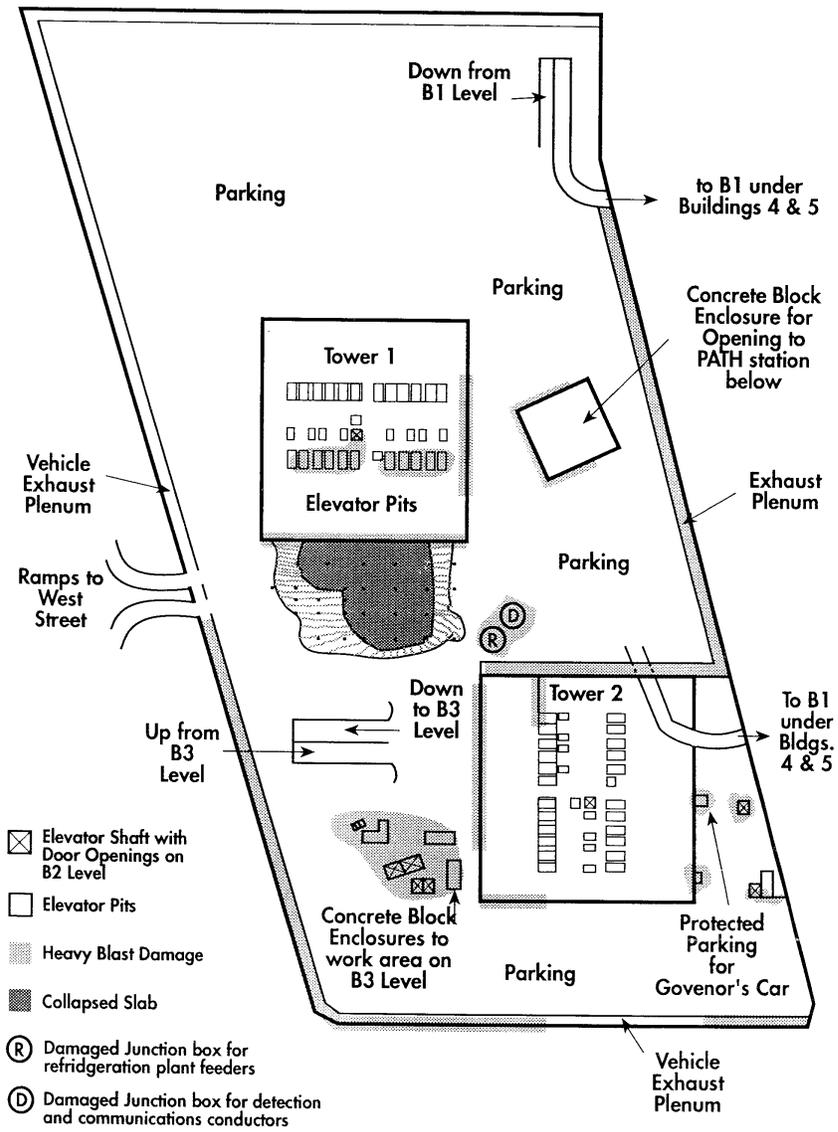
EXPLOSION DAMAGE, B2 LEVEL
Figure 11

Similarly, on the B2 level, many nonbearing walls were damaged or collapsed. (See Figure 11.) The damaged walls included the walls forming the vehicle exhaust plenum along the perimeter of that level, and nonbearing walls enclosing rooms, stairways, and the space above the PATH station were heavily damaged. In addition, the enclosure walls for more than 11 elevator shafts were heavily damaged or collapsed completely. Four of these heavily damaged elevator shafts were for Tower 1 express cars that went to the 44th floor; seven of the shafts were for elevators in the Vista Hotel, and most of these elevators traversed the full height of the building. In addition to the heavily damaged enclosure walls, several enclosure walls for elevator shafts scattered throughout the parking garage sustained a lesser degree of damage, i.e., cracks and/or deflection. These elevators serviced the basement levels terminating at the Concourse level. The damaged walls on the B2 level were located below Towers 1 and 2, the Vista Hotel, and the Customs House, and were up to 550 feet away from the blast area.
