**NIST NCSTAR 1A**

**Federal Building and Fire Safety Investigation of the  
World Trade Center Disaster**

**Final Report on the Collapse of  
World Trade Center Building 7**

**Draft for Public Comment**

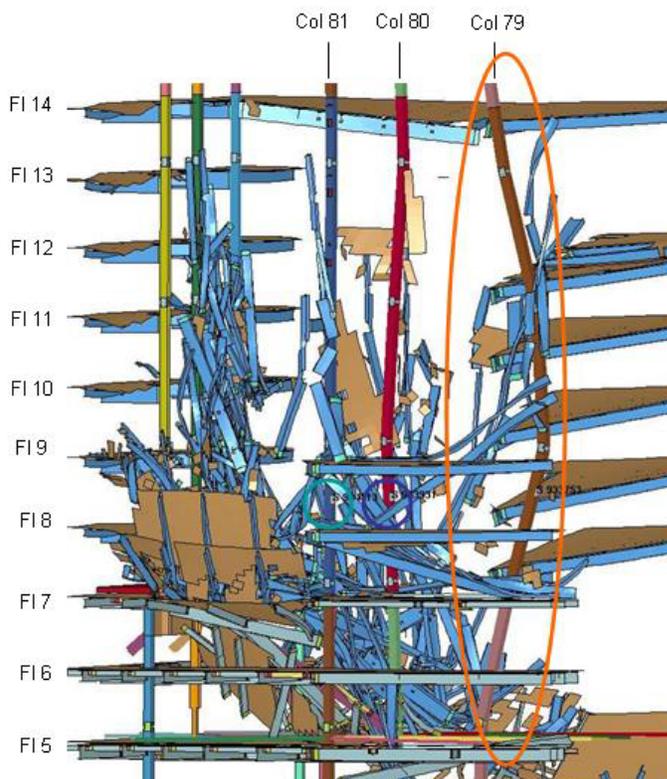
Fire-induced thermal expansion of the floor system surrounding Column 79 led to the collapse of Floor 13, which triggered a cascade of floor failures. In this case, the floor beams on the east side of the building expanded enough that they pushed the girder connecting Columns 79 and 44 to the west on the 13<sup>th</sup> floor. (See Figure 1–5 for column numbering and the locations of girders and beams.) This movement was enough for the girder to lose its connection to Column 79.

The displaced girder and other local fire-induced damage caused Floor 13 to collapse, beginning a cascade of floor failures down to the 5<sup>th</sup> floor (which, as noted in Section 1.2.3, was much thicker and stronger). Many of these floors had already been at least partially weakened by the fires in the vicinity of Column 79. This left Column 79 with insufficient lateral support in the east-west direction. The column buckled eastward, becoming the initial local failure for collapse initiation.

**Figure 2–2. Eastward buckling of Column 79, viewed from the southeast.**

The upper section of Column 79 began to descend. The cascading failures of the lower floors surrounding Column 79 led to increased unsupported length in, falling debris impact on, and loads being re-distributed to adjacent columns; and Column 80 and then Column 81 buckled as well. All the floor connections to these three columns, as well as to the exterior columns, failed, and the floors fell on the east side of the building. The exterior façade on the east quarter of the building was just a hollow shell.

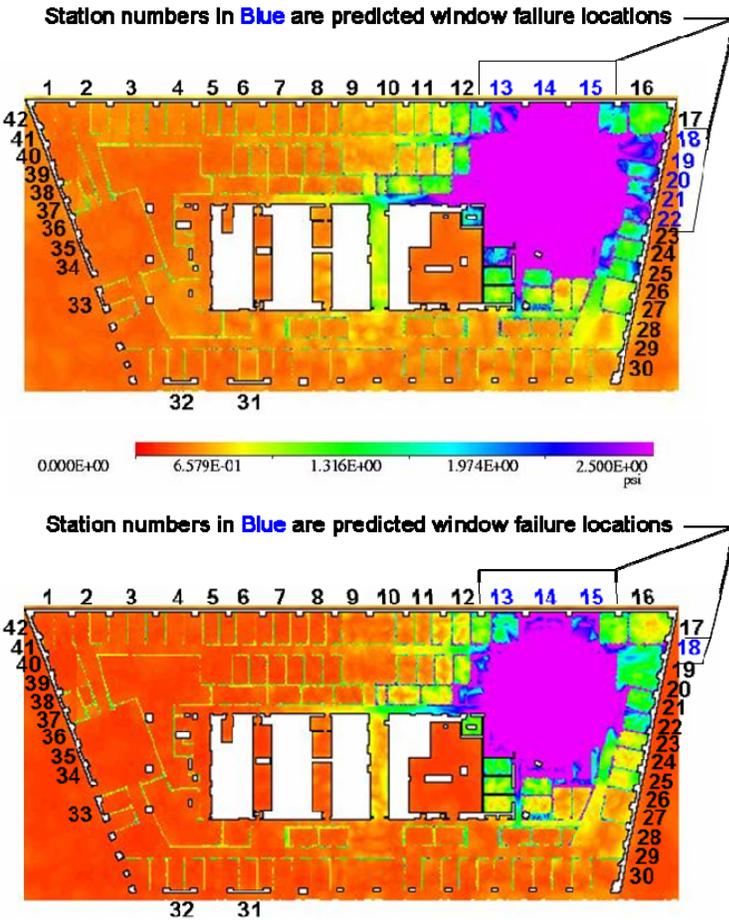
Figure 3–1 shows the results for the two shaped charges applied to Column 79 on a tenant floor that was highly partitioned, such as Floor 12. Nearly all the windows on the northeast section of the blast floor

would have been broken, even by the smaller charge. Simulations for open landscaped floors led to more extensive window breakage.

**Figure 3–1. Peak overpressure and broken window locations.**

Top: 9 lb shaped charge; bottom: 2 lb charge.

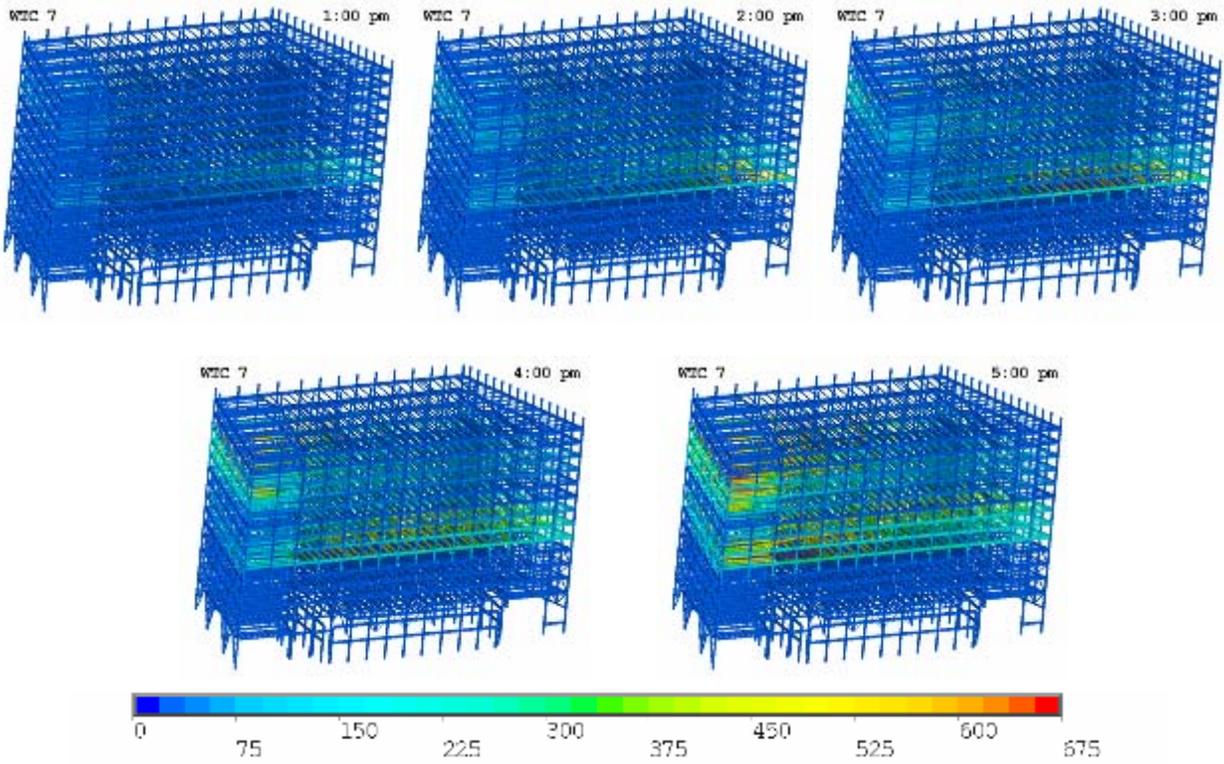
Figure 3–7 shows the calculated heating of the structural steel on the lower 16 floors of WTC 7 for the Case B temperatures from the fire simulation. The floor slabs have been removed from the figure for clarity. Figure 3–8 is a typical rendition of the calculated heating of the top of a floor slab as a result of the Case B fire.

Figure 3–7. View from the northeast of the computed heating of the lower 16 floors of WTC 7 at five different instants in time.

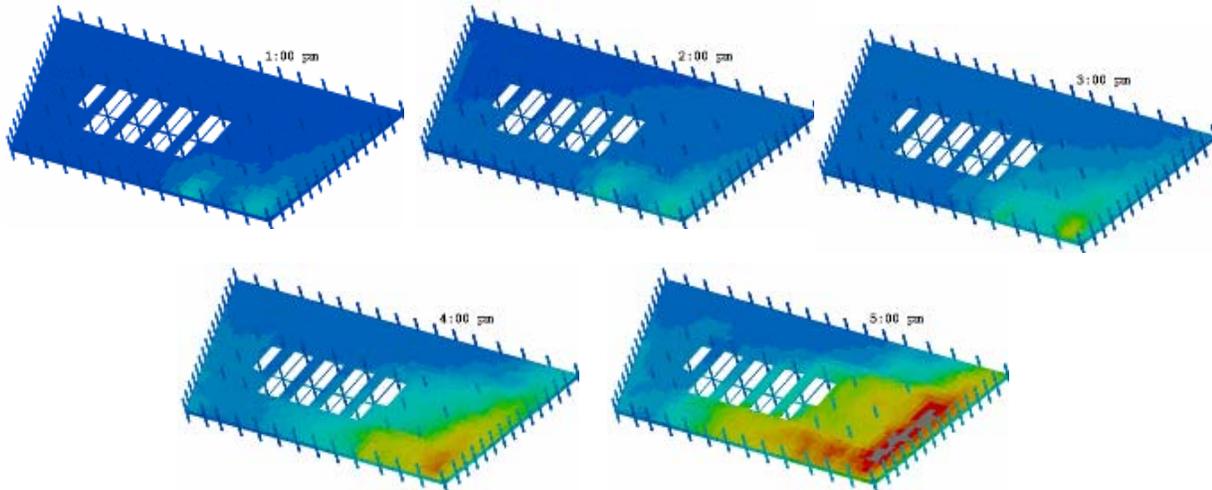
Figure 3–8. Computed temperature distribution (°C) in the top layer of the concrete slab of Floor 12 at five different instants in time.

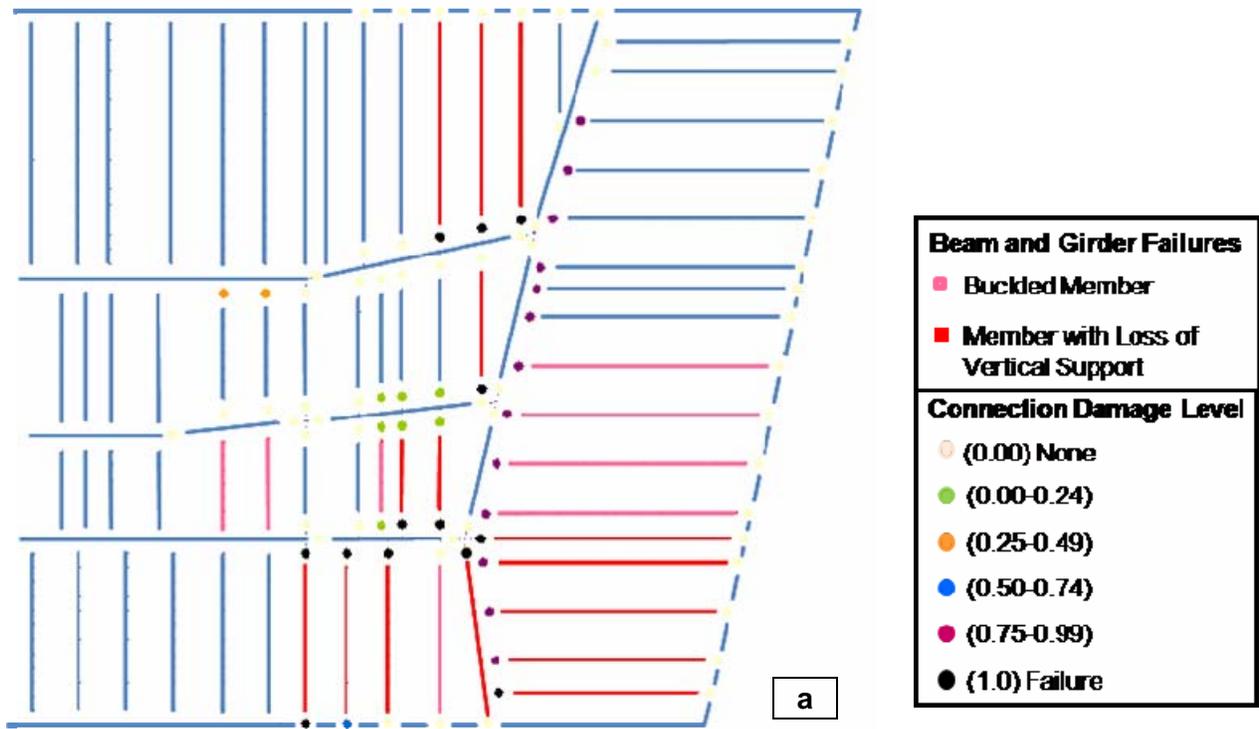
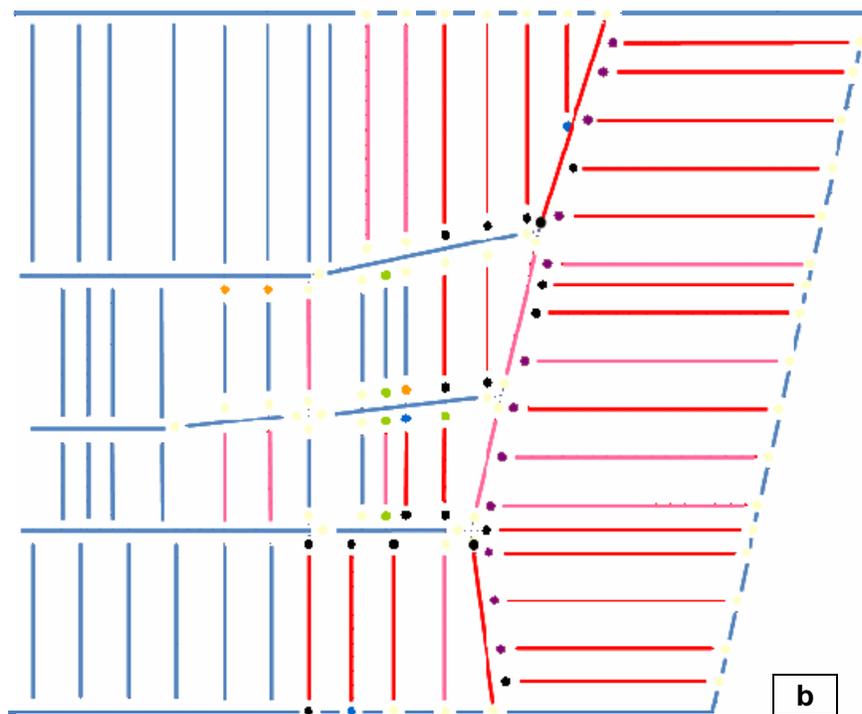
Figure 3-9 shows an example of the extent of structural damage from the fires, in this case for the 13<sup>th</sup> floor. At both 3.5 h and 4.0 h, connections, floor beams, and girders were damaged or had failed at steel temperatures that were approximately 400 °C or less, primarily due to the effects of thermal expansion. After 4.0 h of heating, there was substantially more damage and failures in the WTC 7 structural system than at 3.5 h of heating.

Figure 3–9. Damage state of connections in Floor 13 for Case B temperatures.

a: at 3.5 h; b: at 4.0 h

The second LS-DYNA analysis (lesser degree of fire-induced damage) did not lead to a collapse-initiating event, despite the extensive damage shown in Figure 3-9a.

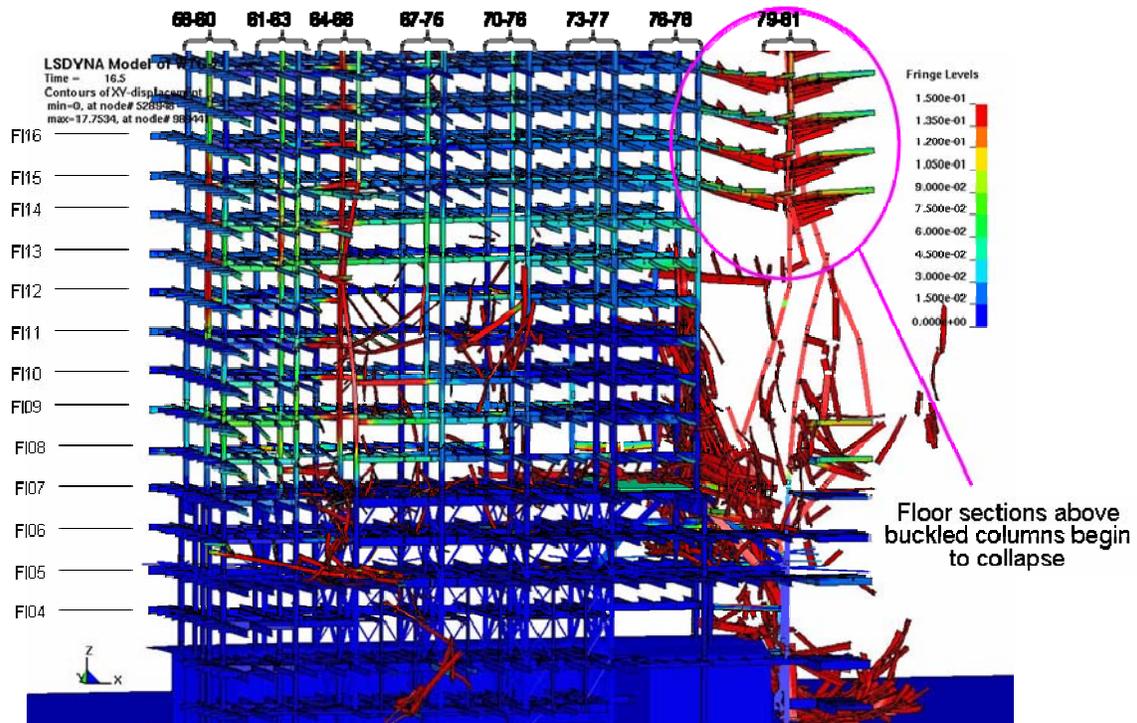
Figure 3–10 shows the beginning of upper floor failures on the east side of the building at 0.5 s, following the buckling of Columns 79, 80, and 81. The east penthouse, which was supported by these three columns, had just begun to descend. About 2 s later, as shown in Figure 3–11, the collapse of all the east sections of all the floors had occurred, the upper floors had moved southward, Truss 2 had been damaged, and the westward progression of the building failure was underway. Figure 3–12 and Figure 3–13, only 2 s apart, indicate the speed with which the westward column failures proceeded between Floors 7 and 14.

Figure 3-10. Vertical progression of failures on the east side of the building at 0.5 s following the initiation of the collapse.

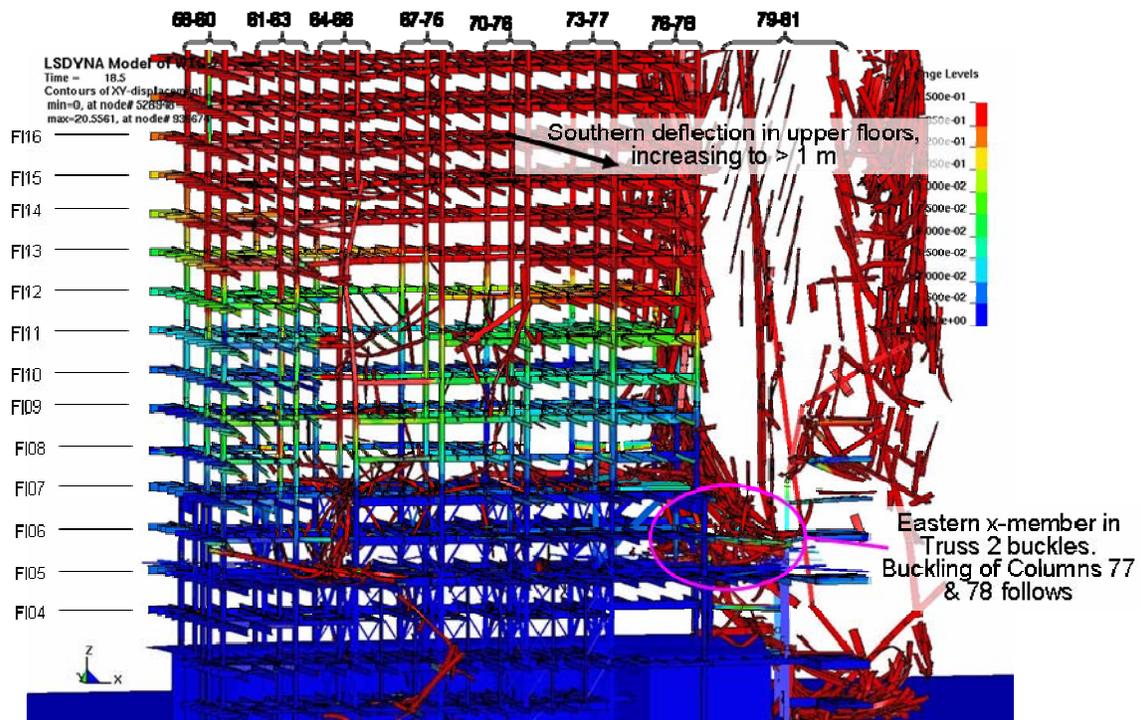
Figure 3-11. Failure of Columns 77 and 78 due to failure of Truss 2 fails from debris impact at 2.5 s following the initiation of the collapse.

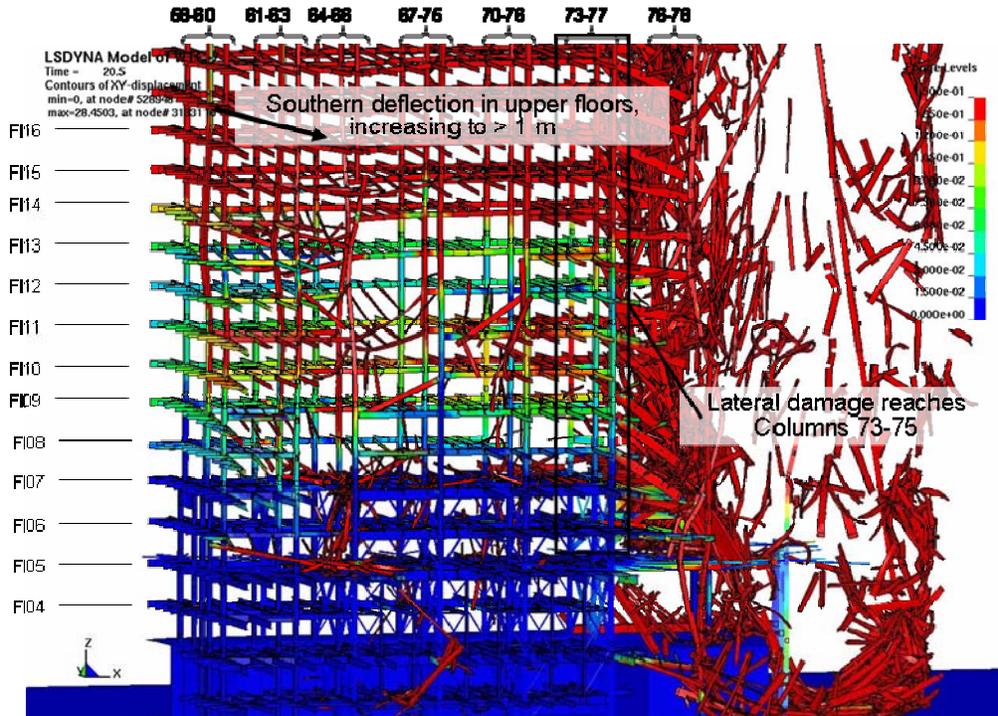
Figure 3–12. Failure of Columns 73 to 75 from the load redistribution and debris impact at 4.5 s following the initiation of the collapse.

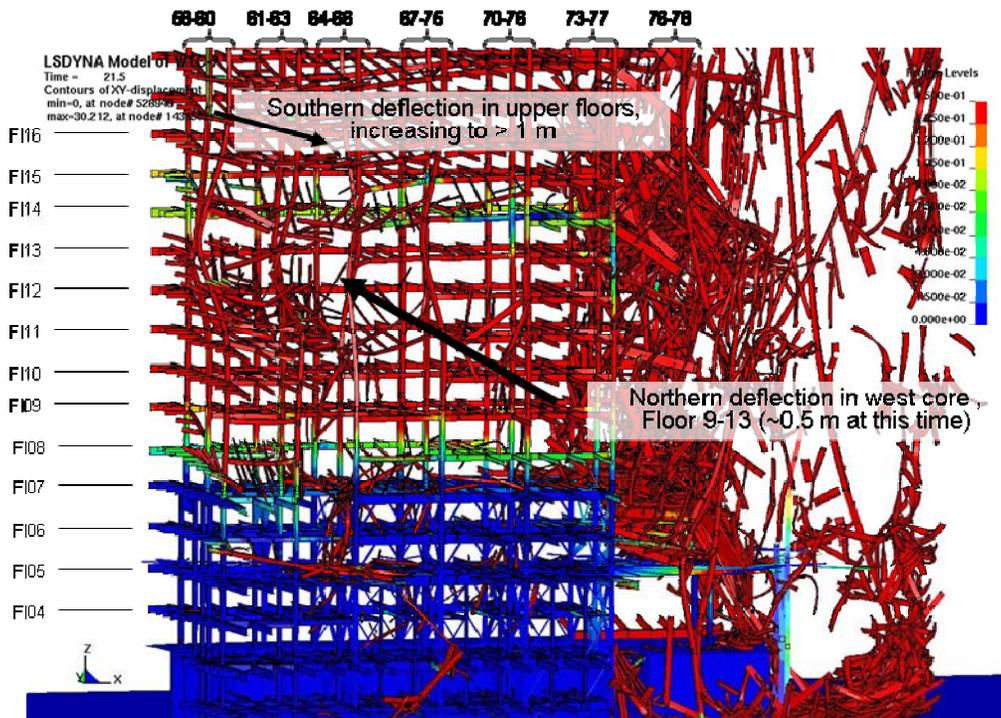
Figure 3–13. Buckling of all interior columns at 6.5 s following the initiation of the collapse.

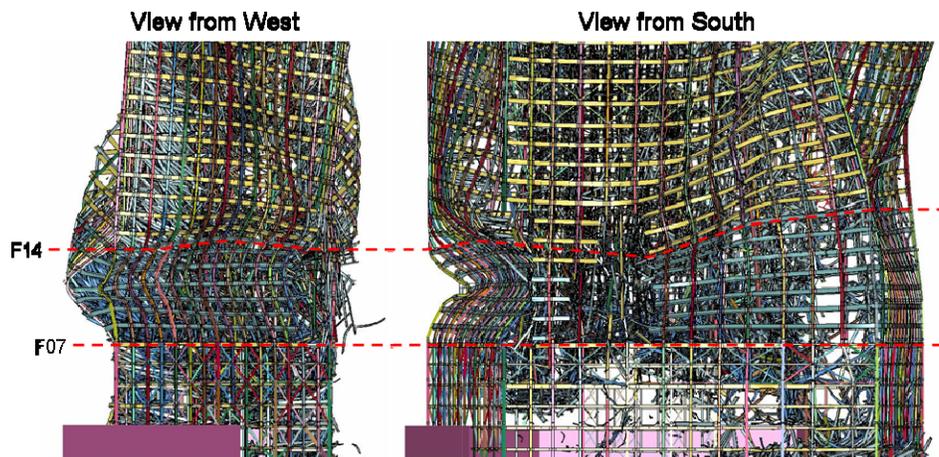
In Figure 3-14, the total collapse of the building is underway. The two views cover the lower half of the building. The purple area at the bottom is the Con Edison substation. With no fires on the west side of Floors 10 through 14, the intact floor framing pulled the exterior columns inward as the interior columns fell downward. Loads from the buckled interior columns were redistributed to the exterior columns, which, in turn, buckled the exterior columns between Floors 7 and 14 within approximately 2 s. At that point, the entire building above the buckled-column region moved downward as a single unit, resulting in the global collapse of WTC 7.

**Figure 3-14. Buckling of the lower exterior columns within 1 s of Figure 3-13.**
