***Direct Visual Signaling as a Means for
Occupant Notification in Large Spaces
Research Project***

Technical report

**An Engineering Study Sponsored by
the Fire Protection Research Foundation**

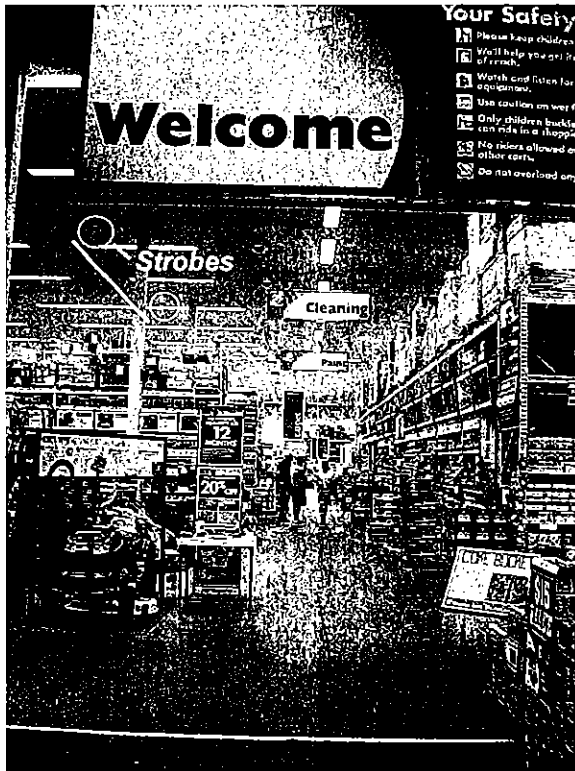
Photo 3 shows lines of strobes on the ceiling. Photo 4 shows an aisle with strobes directly overhead. Photo 5 is a close-up of a strobe on the suspended ceiling.

Photo 3 - Lines of Strobes

The strobes at this location are located on a suspended acoustical tile ceiling at the same level of the building's fluorescent lights. The design and installation resulted in most strobes being located over the aisles, between racks. Within each aisle, the strobes are spaced approximately 48 ft. Rack spacing varies with most 16 ft on center and some as much as 30 ft on center. Thus, strobe coverage might be as low as 48 ft x 16 ft in order to provide a line of strobes in each rack aisle.

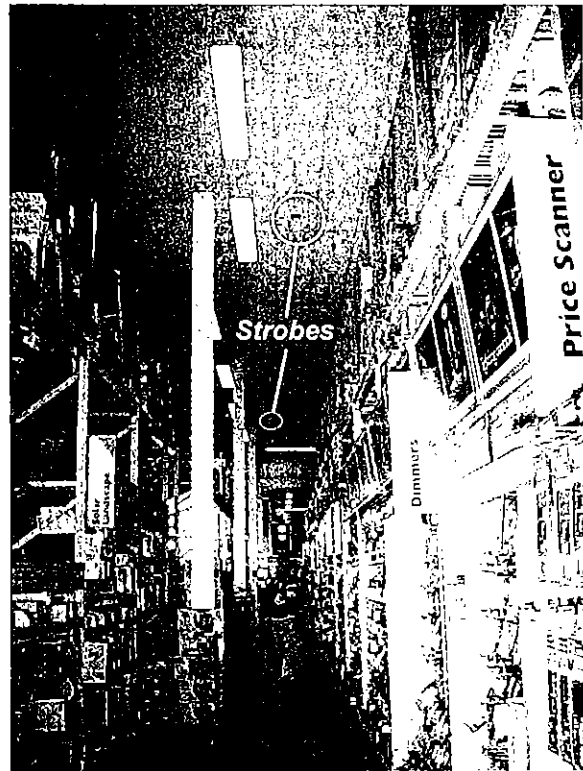
Photo 4 - Strobes Over Aisle

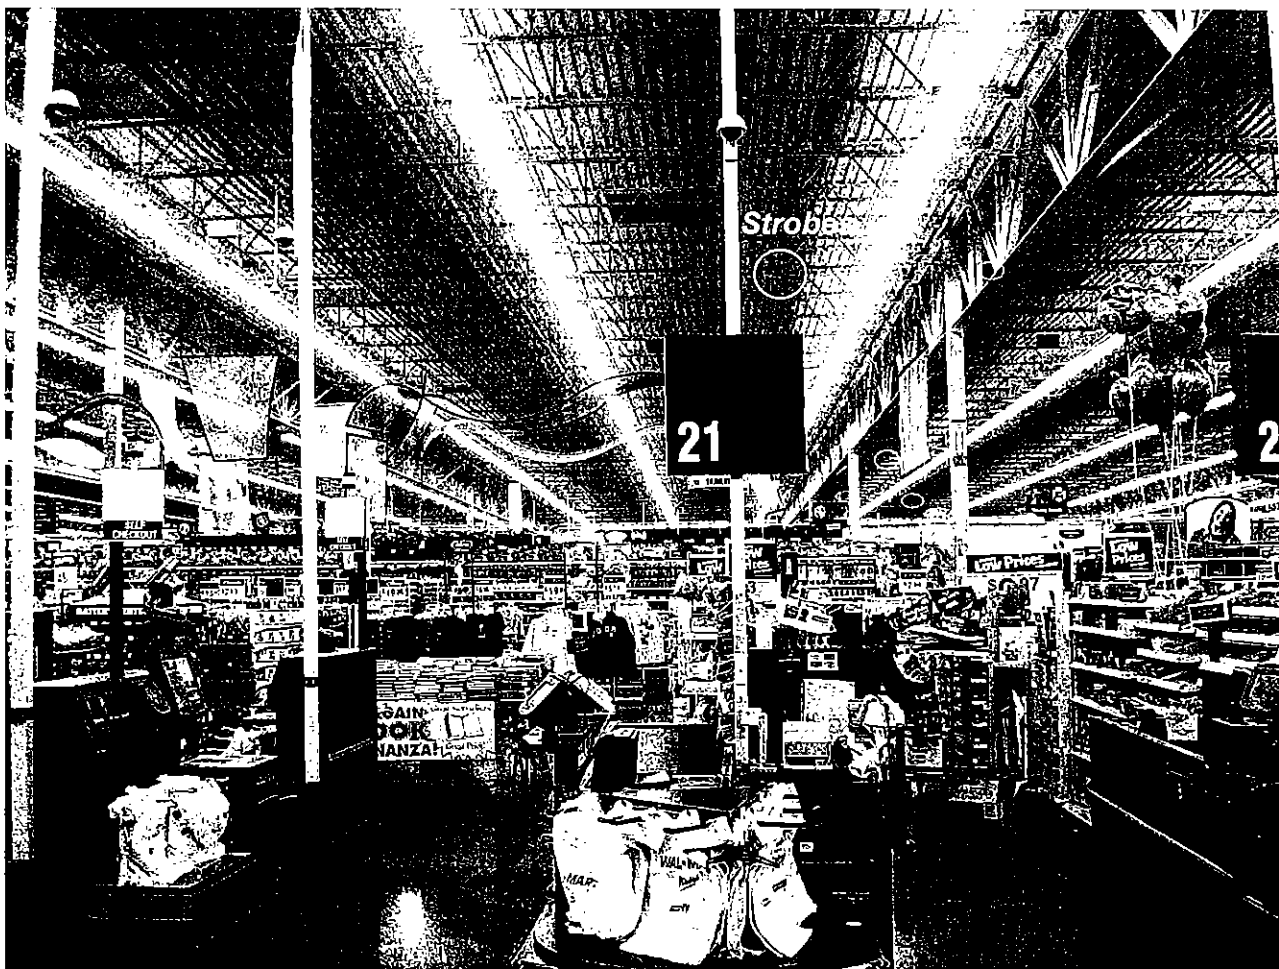
Photo 6 shows the ceiling configuration with strobe lights located on the bottoms of the bar joists.

Photo 6 - Strobes Located on Bottoms of Bar Joists (Kissimmee, FL)

The strobes at this location are located on the bottom of the bar joists supporting the ceiling/roof. The florescent light fixtures are approximately 8 - 12 in. below the bar joists. The design and installation resulted in strobes being located over most of the main aisle and circulation areas. However, not every merchandise aisle has a row of strobes overhead. Typically, the strobes are over the main aisles and over every third to fifth stock aisle.
