FIRE INVESTIGATION REPORT

**World Trade Center Explosion and Fire
New York, New York
February 26, 1993**

**Michael S. Isner
Fire Protection Engineer
National Fire Protection Association**

**Thomas J. Klem
Director of Fire Investigations
National Fire Protection Association**

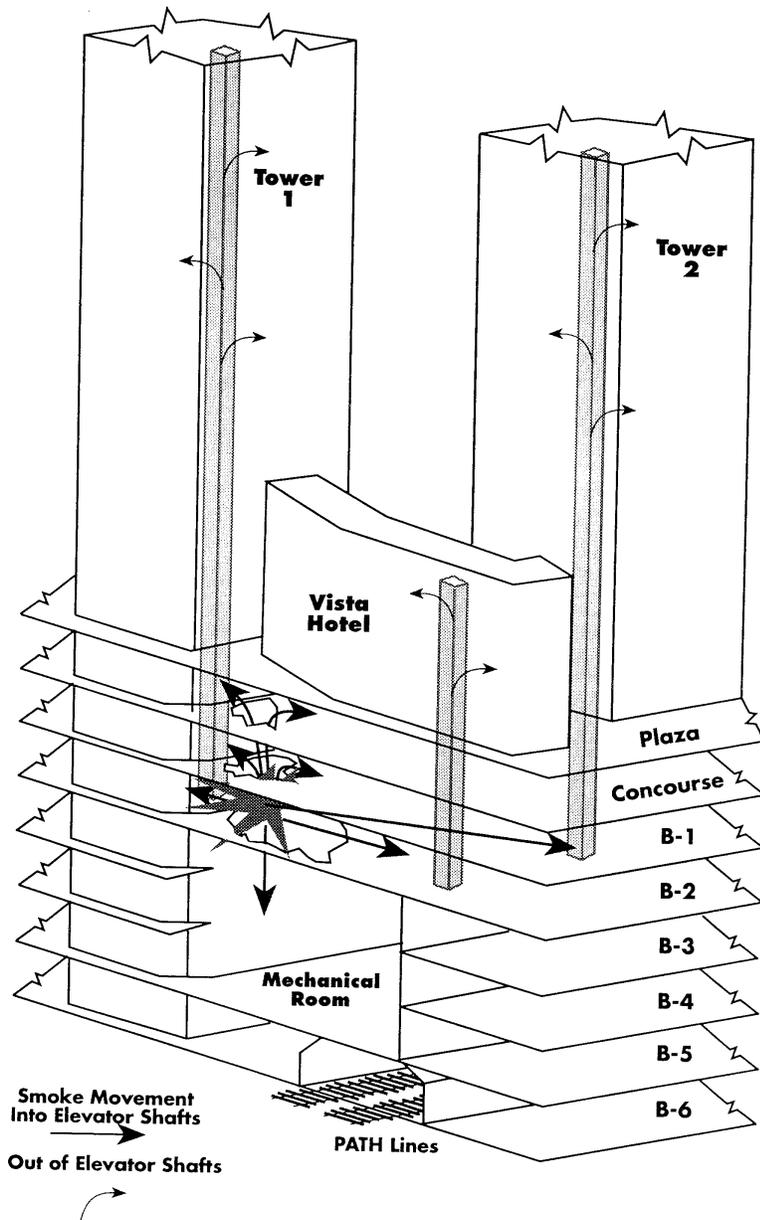
**WORLD TRADE CENTER
Figure 12**

Stack effect forces tended to push smoke into elevator shafts with openings in the lower regions of the buildings. (See Figure 12.) As the smoke moved up the shafts, it eventually began to seep out of the elevator shafts and enter occupied floor levels, even when the elevator doors were closed. The direction of smoke movement, i.e., into or out of elevator shafts, depended on numerous constantly changing variables influencing the stack effect forces. The sky lobbies in the tower provided insight into the complexities of

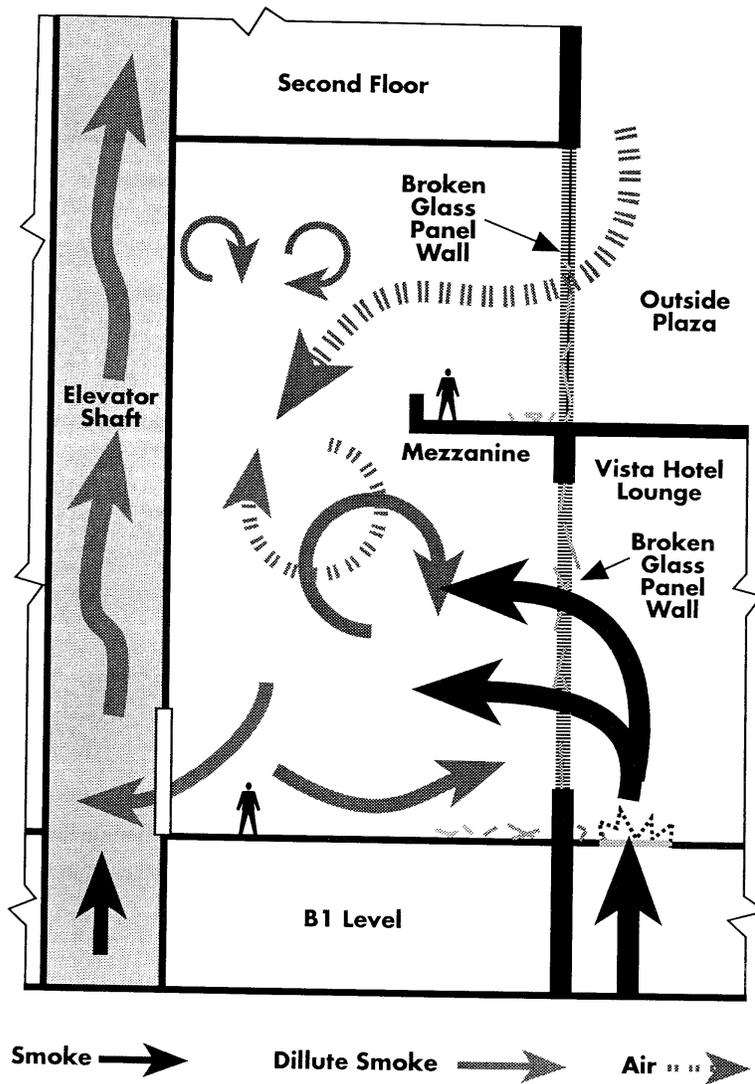
Investigators believe that the dilution of the smoke was a major factor contributing to the survival of occupants. Even though the fires and explosion seemingly involved a large area of the complex, the area was, in reality, a very small part of the complex's total area. As a result, large quantities of air were available in the facility and were drawn into the smoke even before it spread out of the sub-levels. More air was entrained as the smoke moved up through the buildings. For example, the collapsed section of floor slabs allowed smoke and fire in the sub-levels to spread vertically into the Vista Hotel function room. Smoke from this area spread to other areas of the Vista Hotel and spread through broken windows into the lobby of Tower 1. (See Figure 13.) Outside air entering the lobby through broken glass panel walls in the mezzanine mixed with the smoke and probably pushed smoke accumulating in the lobby down to the floor where it could enter elevator shafts that had doors in that area.

LOBBY: NORTH TOWER
Smoke Dillution and Movement
Figure 13
